## NASA SAFETY CENTER SYSTEM FAILURE CASE STUDY

June 2017 Vol. 10 Issue 1

## Smoke and Mirrors: What Went Wrong at L'Enfant Plaza

### **NTSB POINTS TO PROBLEMS WITH INFRASTRUCTURE, MAINTENANCE AND SAFETY OVERSIGHT**

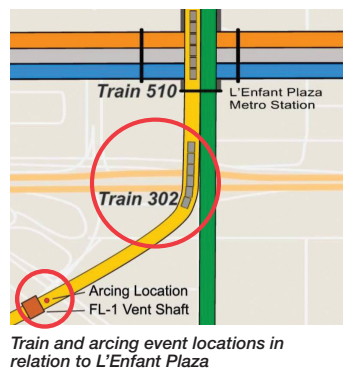
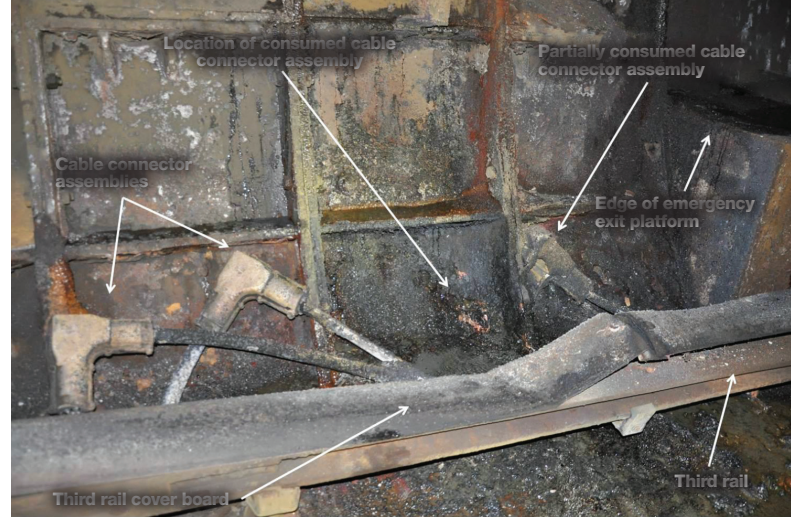
Fire-damaged cables and cable connector assemblies

According to NTSB investigators, “electrical arc tracking at improperly constructed power cable connector assemblies” within the third rail electrical power cable system caused a short circuit that generated fire and smoke in the tunnel. About 16 feet of third rail power cables and sections of the cable connector assemblies were consumed by the arcing event, which lasted nearly 45 minutes.

In addition to the electrical issues, the presence of water at the site of the arcing event increased the severity of the accident.

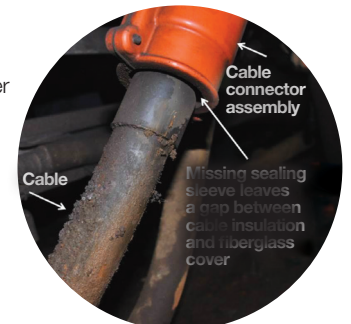
Missing sealing sleeve and resulting gap between cable insulation and fiberglass cover

Sealing sleeves typically are used to keep cable assemblies weathertight in the presence of contaminants and moisture. Although WMATA's engineering design specifications included sealing sleeves, NTSB investigators discovered that the third rail power cable connector assemblies were missing the sealing sleeves that are designed to protect the cable from water and debris.

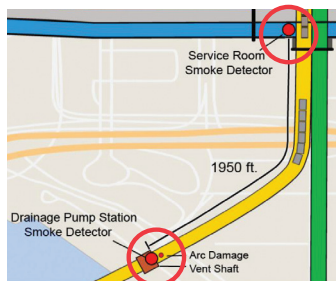
Location of smoke detectors in relation to trains and arc damage

At 3:04 p.m., the first smoke detector was activated. However, notification of this detection was never received by the ROCC or anyone else. The NTSB determined that a loose wire prevented the connection with AIMS, the result of inadequate maintenance.

The NTSB also noted that WMATA lacked the capability to determine the precise location of smoke in the tunnel system since the detectors were spaced too far apart. According to the NTSB, precise location identification of smoke is vital for proper ventilation and survival.

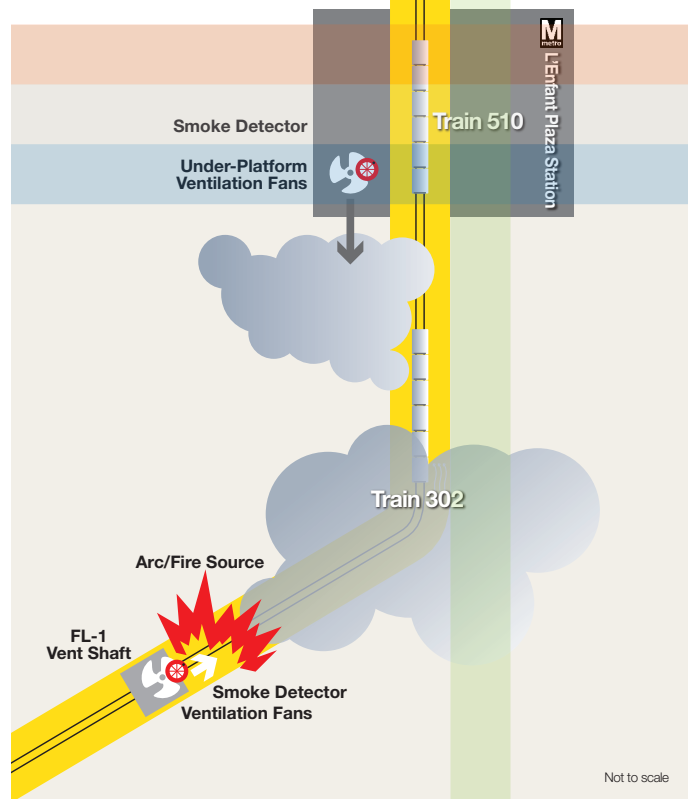
WMATA did not hold any training or develop any procedure to evacuate smoke in train tunnels. Thus, the ROCC train control operator did what seemed best and activated under-platform fans in exhaust mode in the L'Enfant Plaza station, which blanketed train 302 in smoke. It took

eight minutes for the ROCC to activate fans in ventilation shaft FL-1 to emergency exhaust mode. However, no fresh air was being moved in from the outside to help clear the smoke.

Without procedures or system training, the control operator's action to put the fans in exhaust mode blew the smoke toward the train. Since the station fans and ventilation shaft were in exhaust mode, no fresh air supply could be introduced to help move the smoke through the tunnel, toward the outside and away from train 302.

Ineffective ventilation strategy blanketed train 302 in smoke
